#04-03-08-006E: Steering and Front Suspension Noise Concerns-Clunk, Thump, Rattle, Knocking, Pop, Shudder, Vibration (Diagnose and Perform Necessary Repair) - (Nov 1, 2010)

Subject: Steering and Front Suspension Noise Concerns -- Clunk, Thump, Rattle, Knocking, Pop, Shudder, Vibration (Diagnosis and Perform Necessary Repair)

Models: 2005-2010 Chevrolet Cobalt (Including SS)
2006-2010 Chevrolet HHR (Including SS)
2005-2006 Pontiac Pursuit (Canada Only)
2007-2010 Pontiac G5
2003-2007 Saturn ION

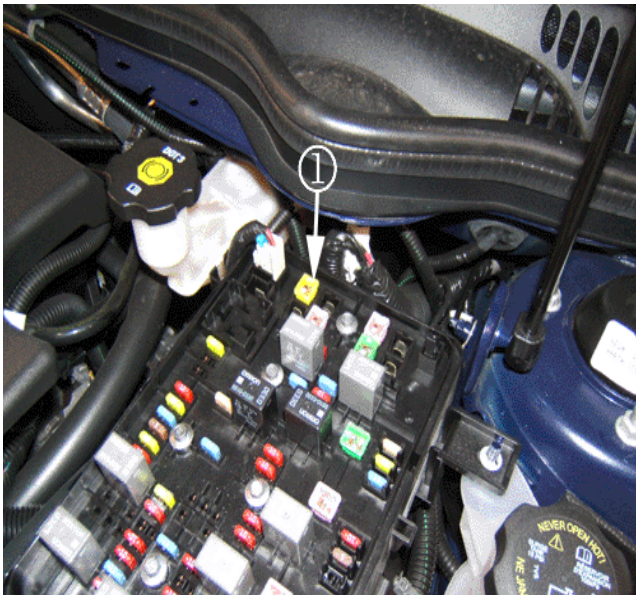
3. Remove the 60 amp EPS fuse (1) in the underhood fuse block.
4. Test the vehicle as in Step 1. Since the EPS motor is no longer powered, only the I-shaft and steering gear/rack will be loaded as you make the turn. If you hear the rattle/knocking noise during the turn, then the noise is being generated by the backlash within the steering column (assist motor gear mechanism).
5. Replace the 60 amp EPS fuse and repeat Steps 1 and 2 to verify that the rattle/knocking noise disappears when turning (loading steering mechanism) and can only be heard when releasing the steering wheel.

If the steering column is identified as the source of the rattle/knocking noise in the above test, replace the steering column.

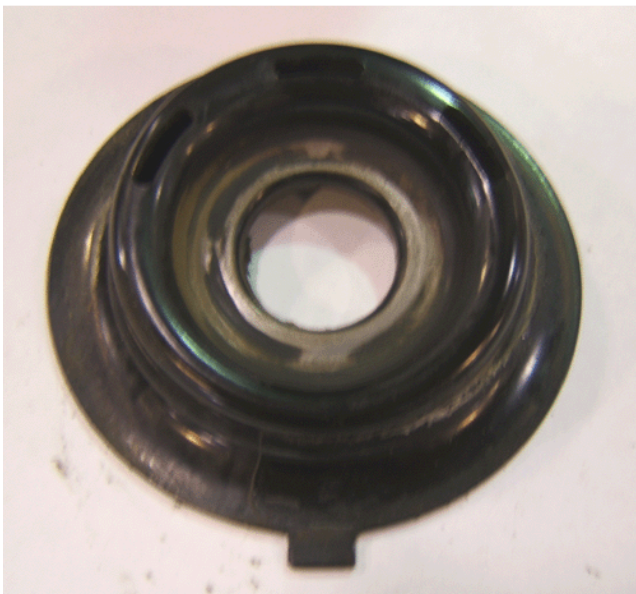
This condition may be caused by the jounce bumper slamming into the upper spring seat because it is not retained in the correct up position. The jounce bumper loses position due to oil being deposited onto its retention fingers. The oil is from the strut leaking.

Inspect the front strut(s) for evidence of oil. The leak may be slight but will still cause the concern. If oil is present, replace the affected strut, jounce bumper and dust boot (shield). Before reassembling the strut assembly, glue the new jounce bumper and new dust boot (shield) to the upper spring seat using the steps listed below. To further confirm this concern, the shield/bumper will easily slide up and down the strut shaft.

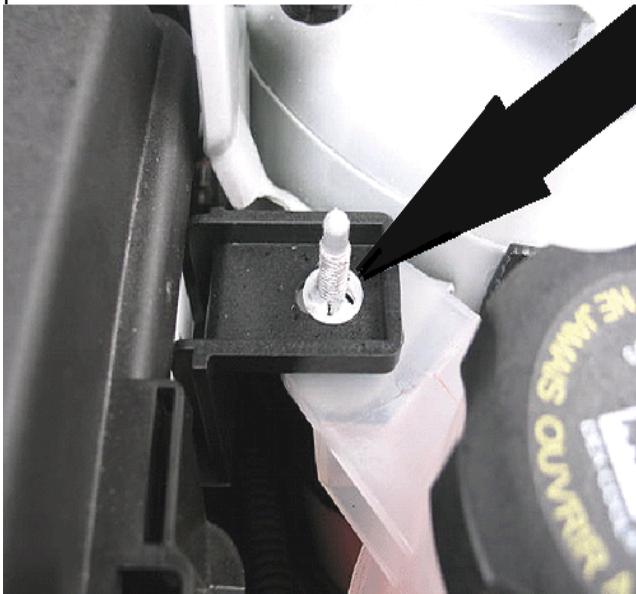
Rattles/clunks in this area of the engine compartment may be heard as coming from the steering column while driving.

2. Check that the retaining clip on the engine coolant surge tank is fully seated. If not, push down to seat.

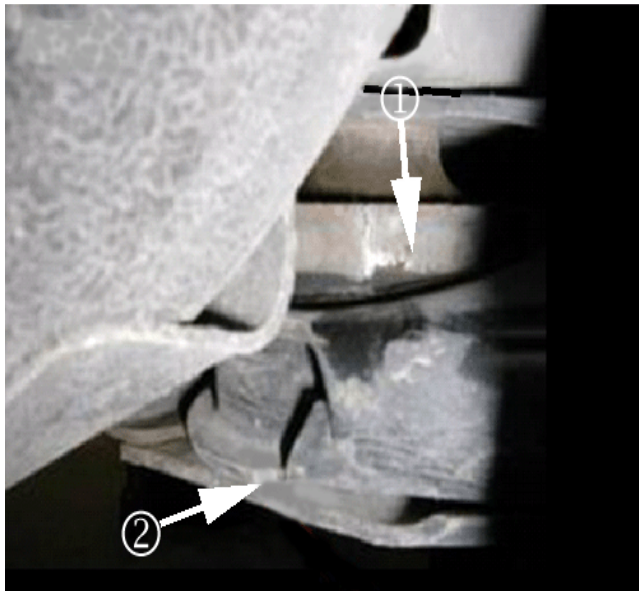
This condition may be caused by the lower control arm rubber bushing (rear) coming out of its steel sleeve (1). This will cause the lower control arm to make hard contact (2) with the body structure. This condition may be more prevalent in regions that use road salt during the winter months.

If the rubber bushing has moved out of the steel sleeve, replace the lower control arm bushing. Do not replace the bushing if it is still centered in the steel sleeve.

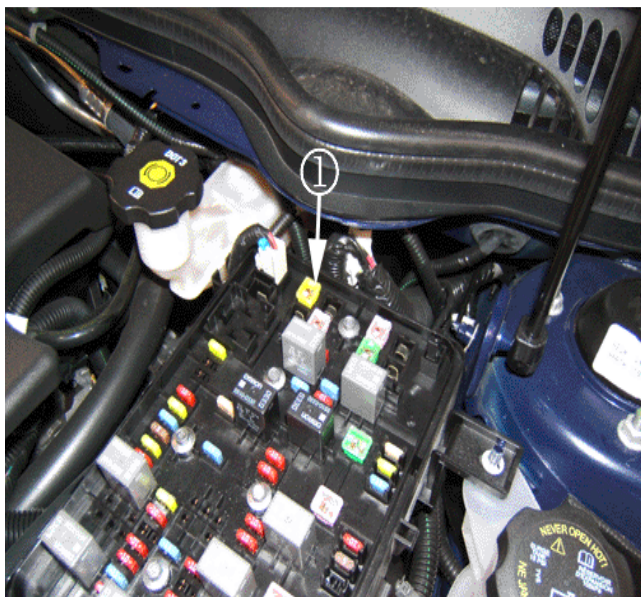
Some customers may comment on a whine/hum noise from the steering column while making right hand turns at 5-15 mph (8-24 km/h). A slight whine/hum noise is considered to be normal for EPS so it will be helpful to compare to another like vehicle. If the vehicle exhibits excessive feedback/noise when compared to another vehicle, follow the correction procedure below.

Pull the 60 amp steering fuse (1) in the underhood fuse block. If this eliminates the whine/hum concern, contact the Technical Assistance Center for further information in order to repair the vehicle. If this does not eliminate the noise, continue to diagnose the vehicle according to the diagnostics in SI.
