#06-07-30-004G: Various Concerns with Shifter and/or Ignition Key (Perform Repair as Outlined) - (May 27, 2010)

Models: 2005-2010 Chevrolet Cobalt
2006-2010 Chevrolet HHR
2005-2006 Pontiac Pursuit (Canada Only)
2007-2010 Pontiac G5
with Automatic Transmission 4T45-E (RPO MN5)

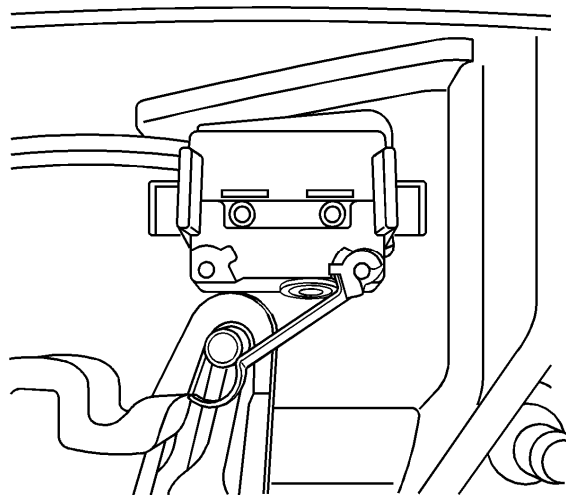
Some customers may comment they cannot remove the ignition key.

The pin that activates the micro-switch may have moved out of position (refer to illustration above). This causes the micro-switch to fail to engage when the vehicle is placed in Park. If this condition is present, the customer will not be able to remove the key from the ignition.

Verify that the micro switch is out of position. Replace the shifter assembly. Refer to Transmission Control Replacement in SI.

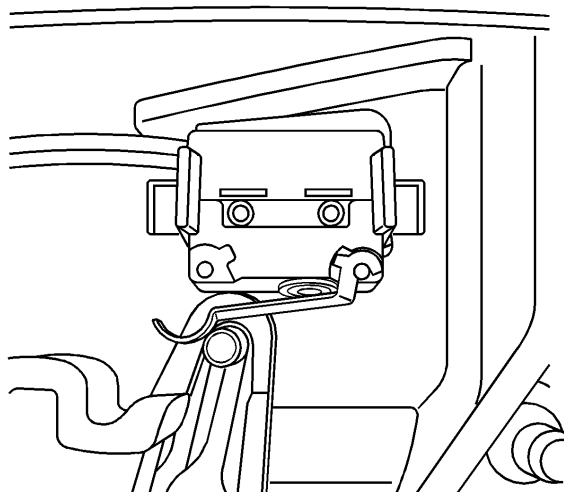
The illustration above shows the switch in a correct position.
