#07-08-57-001B: Water Leak, Front and Rear Carpet Wet, Mildew Odor When A/C is Turned On or Blower Motor Inoperative (Reseal Body Seams) - (Nov 29, 2007)

Models: 2006-2008 Chevrolet HHR

This bulletin is being revised to include an additional water leak concern at the outside mirrors. Please discard Corporate Bulletin Number 07-08-57-001A (Section 08 -- Body and Accessories).

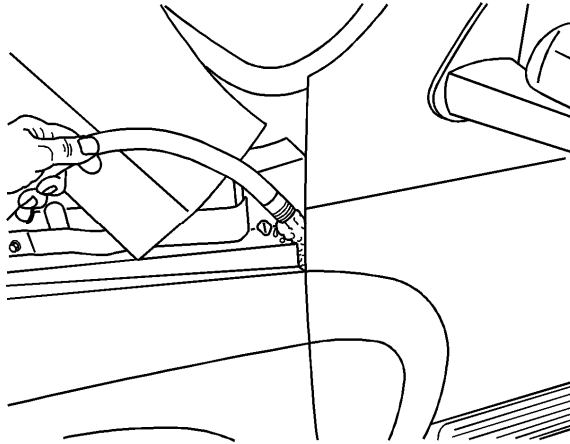
1. Open the hood.
2. Remove the sill plate and the kick pad trim.
3. Pull the carpet and the barrier pad up and remove the rubber baffle plugs from both sides of the vehicle.

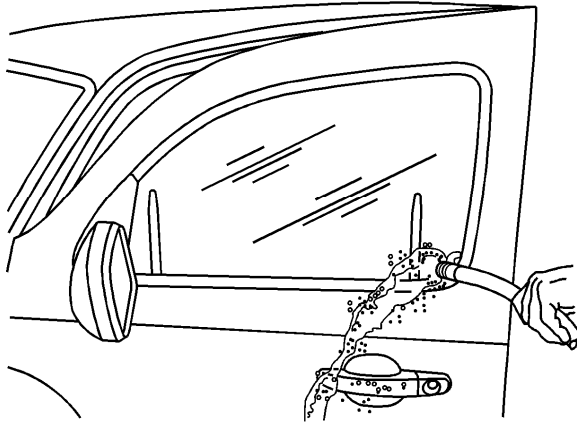
4. Water test the wire harness pass thrus on both front doors. Allow water to flow 60 seconds per side.

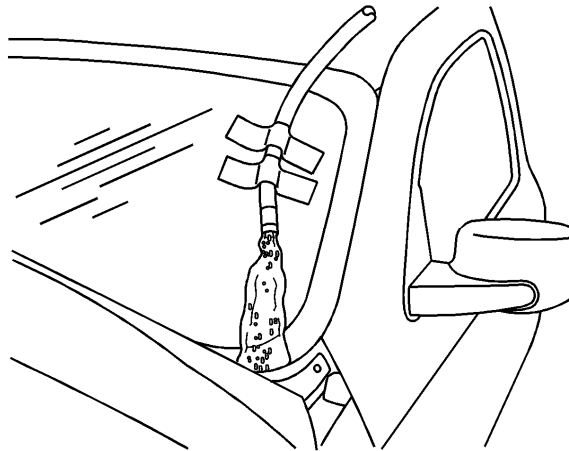
5. Install two trim sticks between the glass and the belt molding as seen in the illustration above. Apply water to the door for 30 seconds and inspect for water coming out between the door trim and deflector. If necessary, remove the door trims and inspect the water deflectors at all four doors for leaks. Refer to Front and Rear Side Door Trim Panel Replacement in SI.
6. After testing all four doors water/dust deflectors, inspect the front floor pan for water from step 4.

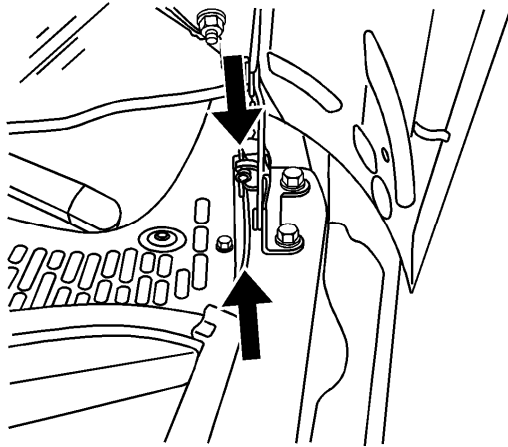
7. Tape the hose onto the windshield allowing water to flow over the entire hood hinge area for 8 minutes as seen in the illustration above. If water is noted in the baffle area, DO NOT STOP. The body sealer area below the base of the A pillar may also be leaking.

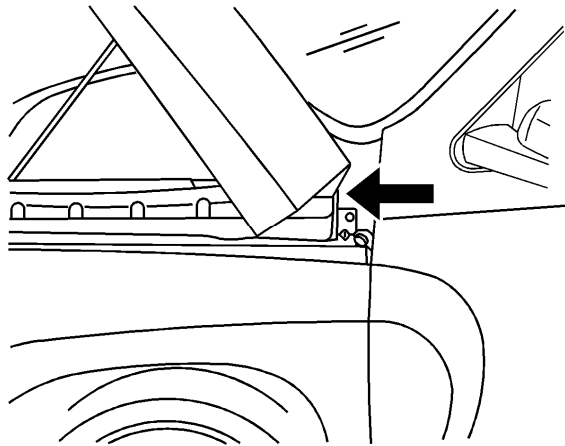
8. Run water onto the trailing edge of the front fender for a minimum of two minutes. Inspect for water in the baffle area again.
9. Run water onto the body seam at the rear of the strut tower for a minimum of two minutes and inspect for water in the baffle area.

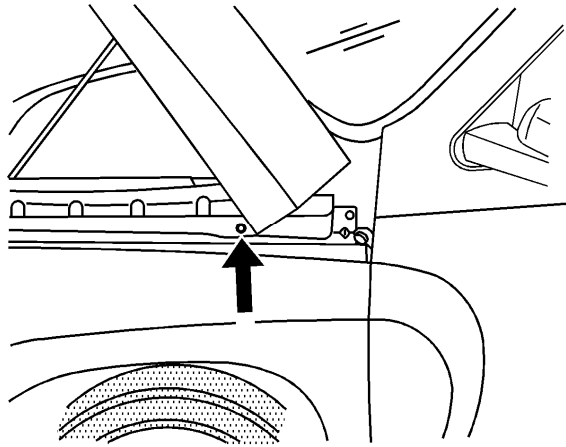
10. Run water into the fender / hinge pillar alignment hole for two minutes. Inspect for water in the baffle area again.
11. Place the barrier pad back to its original position.
12. Lift the module plate barrier pad up.

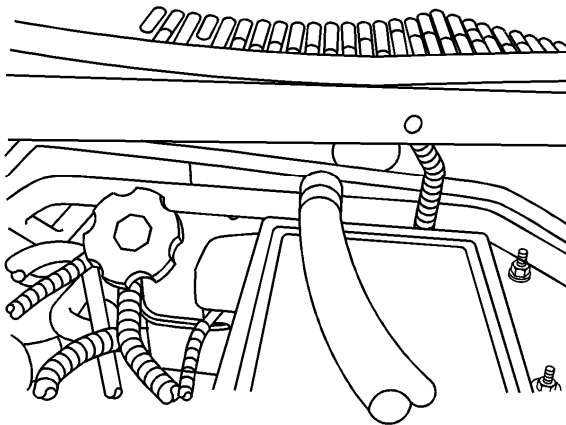
13. Direct water onto the module plate as seen in the illustration above.
14. Inspect the module plate for leaks at the guide pin or the plate to the sheet metal.
15. Direct the water behind the engine insulator pad on the right side of the engine compartment, directly above the rear window washer hose. Water may be entering in this area.

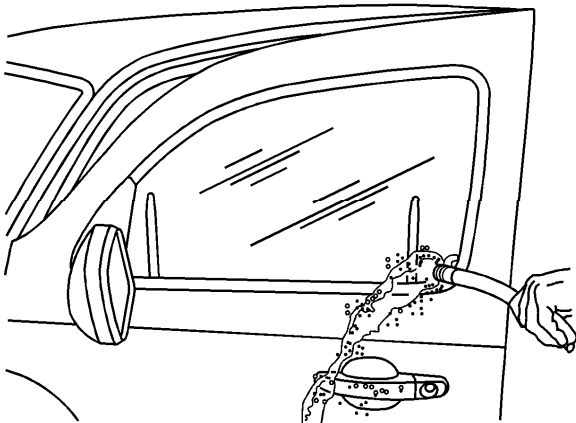
Correction 1

Carpet wet in the front or the rear.

The water deflector adhesive may not be sealed to the door and the drain hole may be covered over with adhesive.

Use two plastic trim sticks and install the sticks between the belt molding and the glass as seen in the illustration above. With the door open, apply water to the glass. Water should only come out of the drains. If water is seen coming from behind the door trim, replace the water deflector. Refer to Front Or Rear Side Door Water Deflector Replacement in SI.

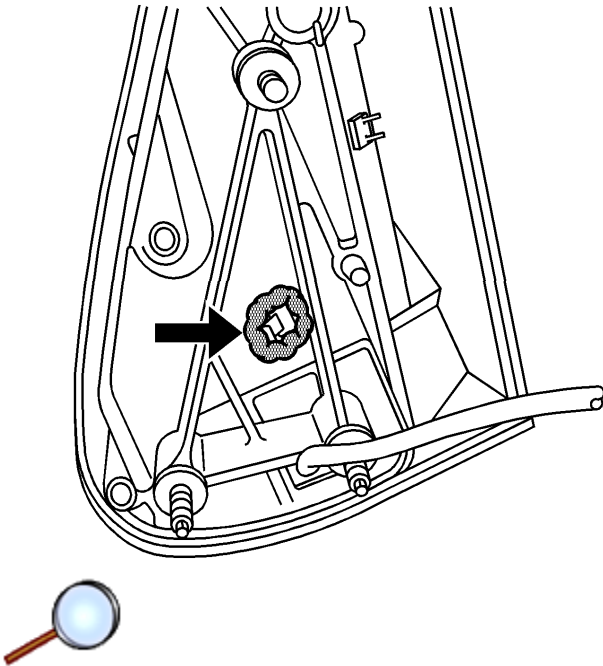
Correction 2

Carpet wet in the front.

Water may be entering the mirror.

Remove the outside rear view mirror and seal the retention clip. Refer to Outside Rearview Mirror Replacement.

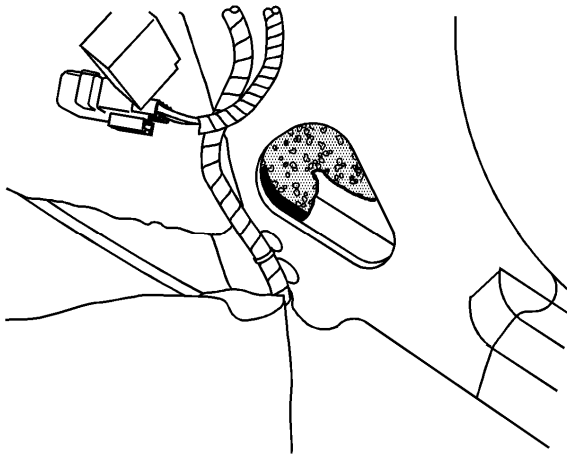
Correction 3

Carpet wet in the front.

Water may be entering the hinge baffle area and draining into the vehicle interior, water leak cowl area from the rear wiper washer hose grommet, door to hinge pillar wire harness pass thru, module plate or body seams.

Remove the hinge baffle (kidney plug). With a heat gun, heat the foam and compress it or cut a channel in the foam to allow water to drain through the rocker. Take a small cup of water and pour it into the baffle area on the right and left sides and observe the water draining out of the lower rockers. If water is coming from under the barrier pad or module plate pad, the complete IP and HVAC will have to be removed to make the repairs.
